CENTRAL INTELLIGENCE AGENCY

INFORMATION REPORT

Soviet Helicopter

Soviet Helicopter Observed Over Toepchin

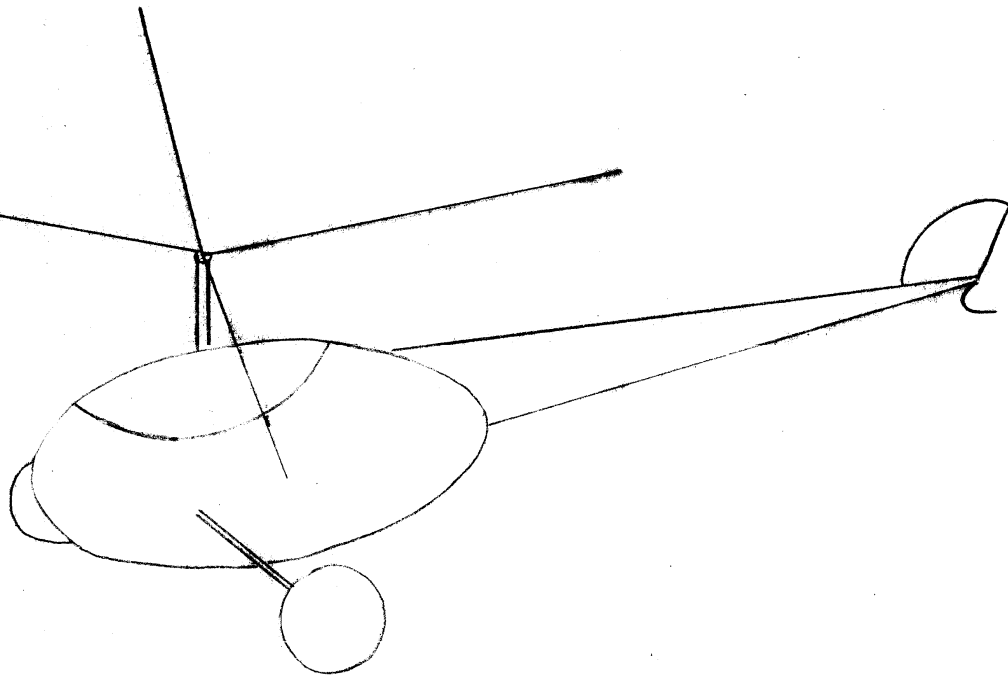
Annex

Cabin: Egg-shaped, 2 to 3 meters long, about 1.7 meters high, upper section glazed. The cabin was painted olive drab. It could not be determined if it was of metal or plywood construction or if it was covered with linen. It was occupied by one man, and only his head could be seen.

Tail unit: It allegedly consisted of 2 thin planks, 3 to 4 meters long, which tapered to the rear. The upper plank seemed to be wider than the lower. The wide sides of the planks were parallel to the ground. A rudder assembly, about 50 cm high and apparently covered with fabric, was mounted on the tail. ¹

Rotor: A twin-rotor was mounted on a shaft. The blades were definitely tilted upward. It could not be determined whether the rotor was made of wood or metal. ²

2. Comment. As no propeller was observed at the tail of counteract the rotor torque, it is believed that the helicopter had two rotors rotating in a horizontal plane and in opposite directions. For sketch of helicopter see Annex.
3. Comment. A helicopter with open tail has not been known so far. The helicopter possibly is of the same type as the one observed
